Kinsey Bridge Metal Grid Deck Replacement

PRESENTERS:

BRENT SCHILLER, P.E., S.E.

JARED LARKIN, E.I.T.

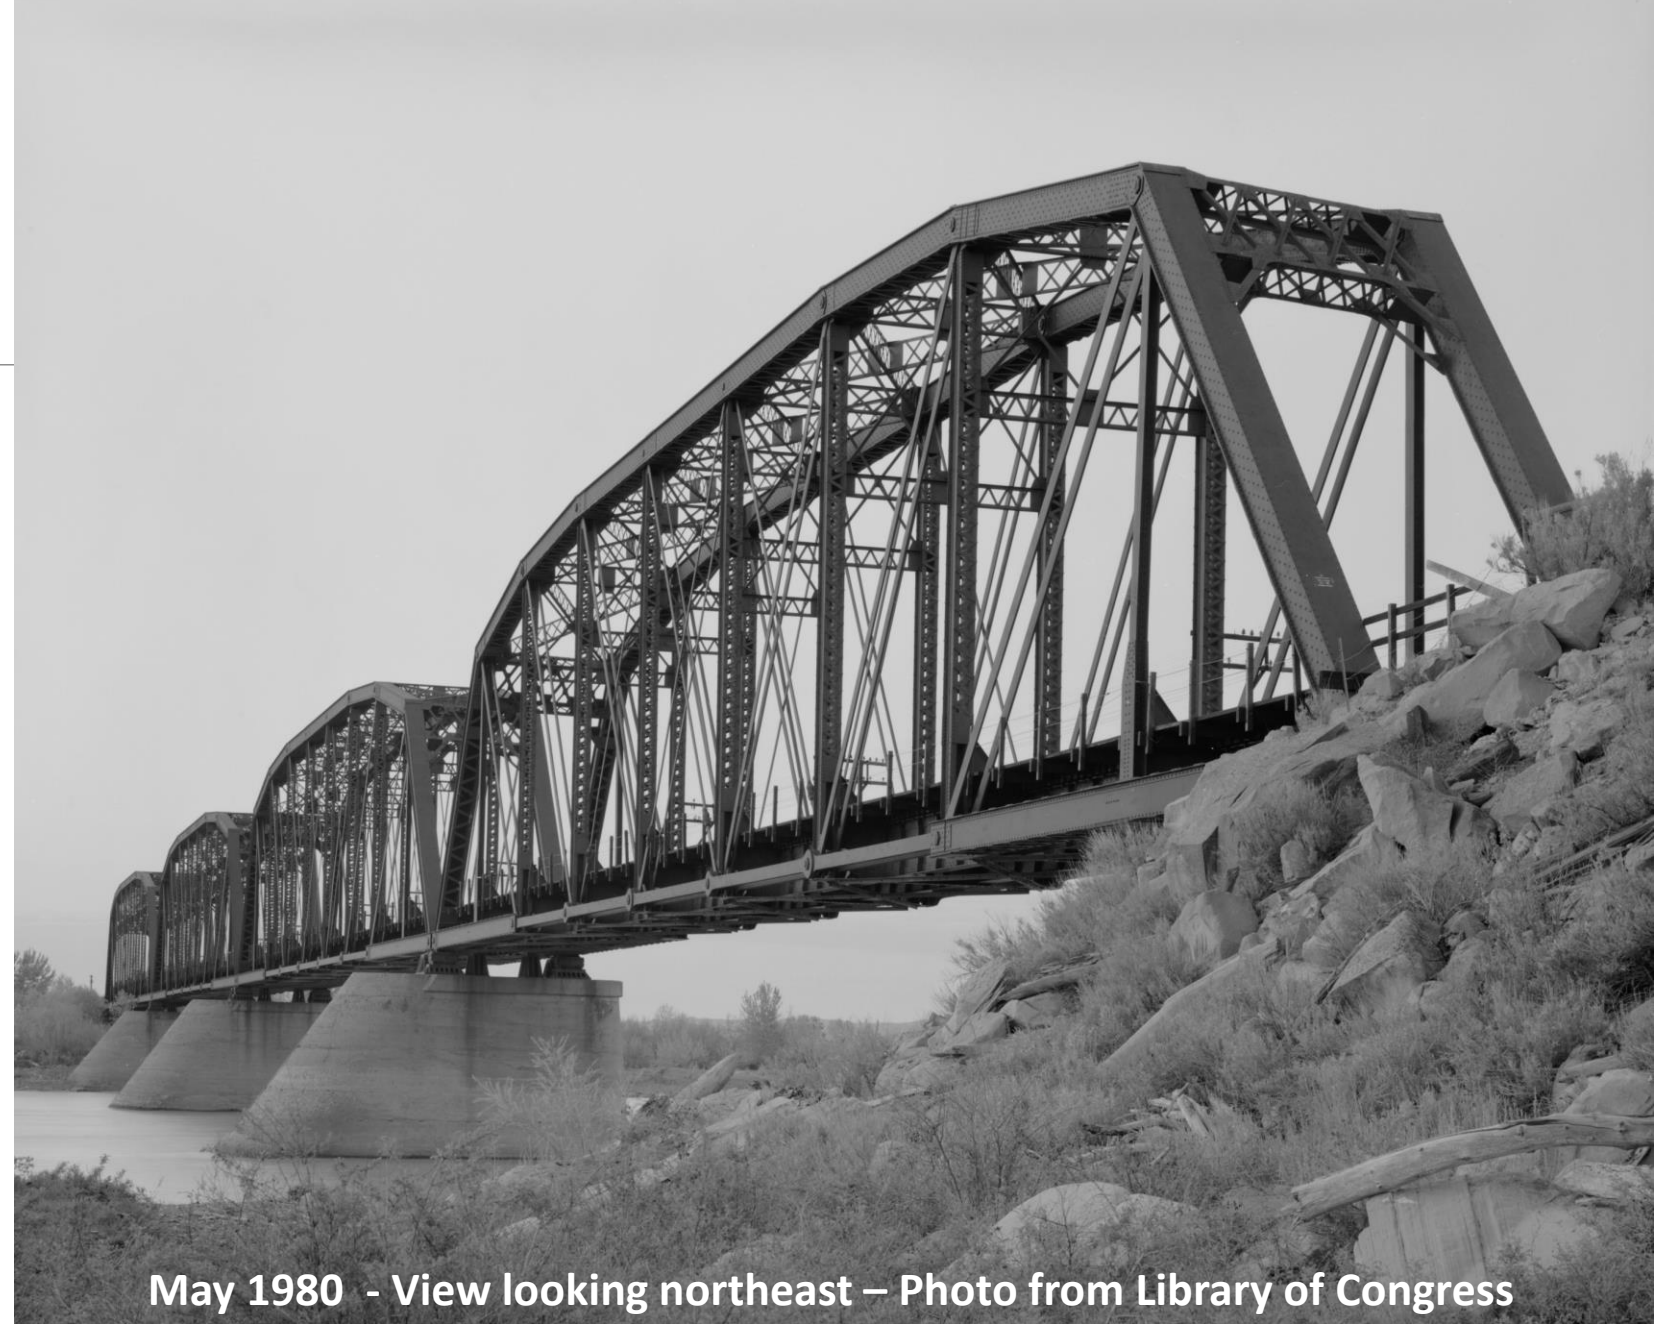
- ❖ Built in 1907 – 116 years old
- ❖ Single track railroad bridge for Chicago, Milwaukee, St. Paul & Pacific Railroad
- ❖ 4 Parker Through Trusses (270')
- ❖ Bridge length of 1080 feet.
- ❖ Skew of 10 degrees.
- ❖ Abandoned by Railroad in 1980

May 1980 - View looking northeast – Photo from Library of Congress

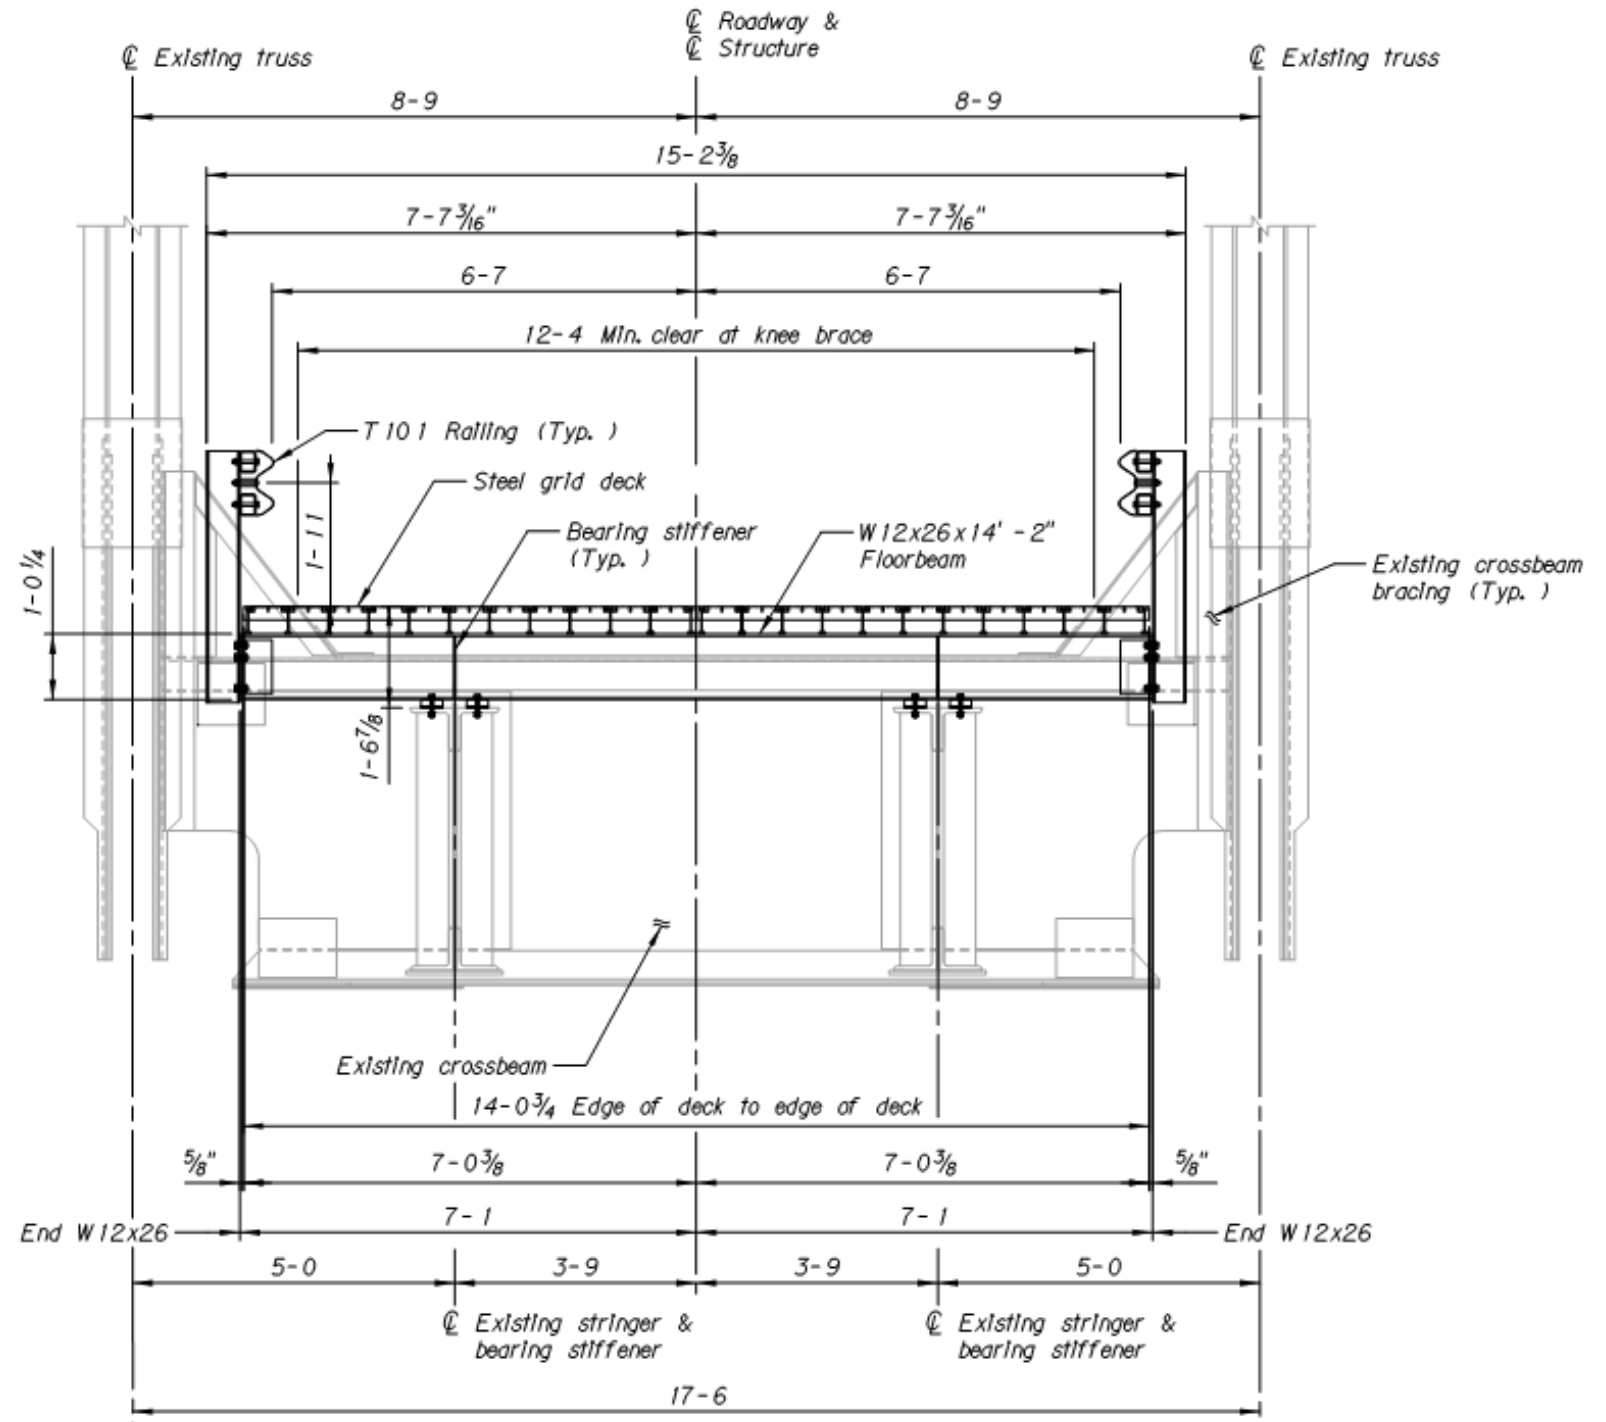
New Typical Section

- ❖ Existing Longitudinal Stringers Spaced at 7.5'
- ❖ Looked at spanning transversely over stringers – It would not work.
- ❖ Added New Transverse Floorbeams to reduce deck spans & remove deck overhangs.
- ❖ Deck to Floorbeam Connection
 - Consulted with the Bridge Grid Flooring Manufacturers Association (BGFMA), Fabricators, and Local Bridge Contractors.

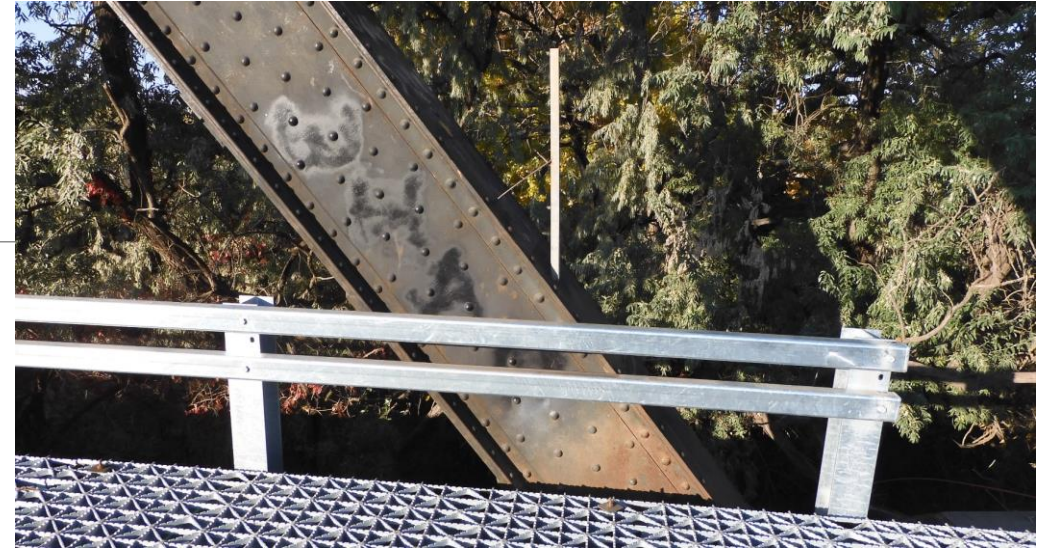
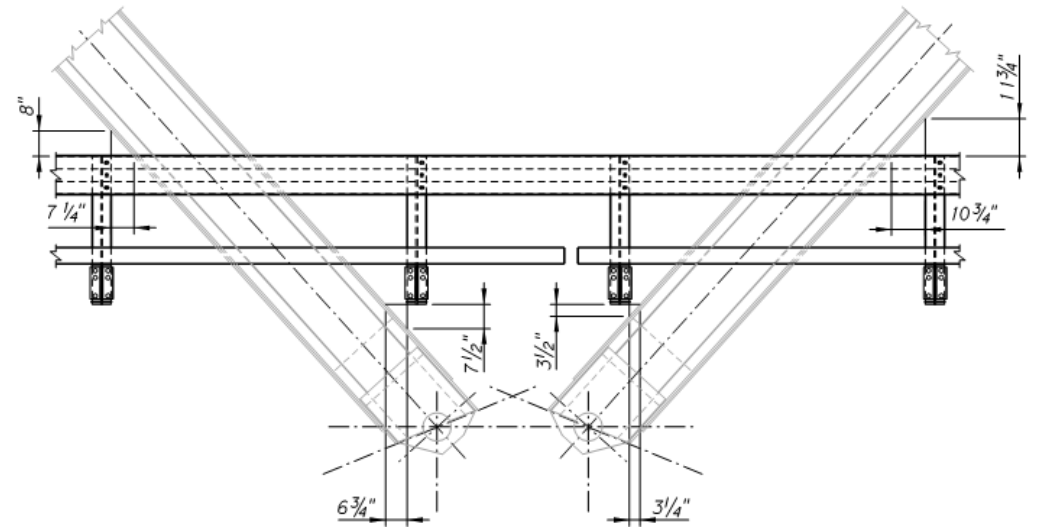
New Railing & Post Spacing

- ❖ Maximum post spacing of 8'-4"
- ❖ Posts were attached to the Floorbeams to reduce costs.
- ❖ Spacing adjusted to avoid truss members at span ends.

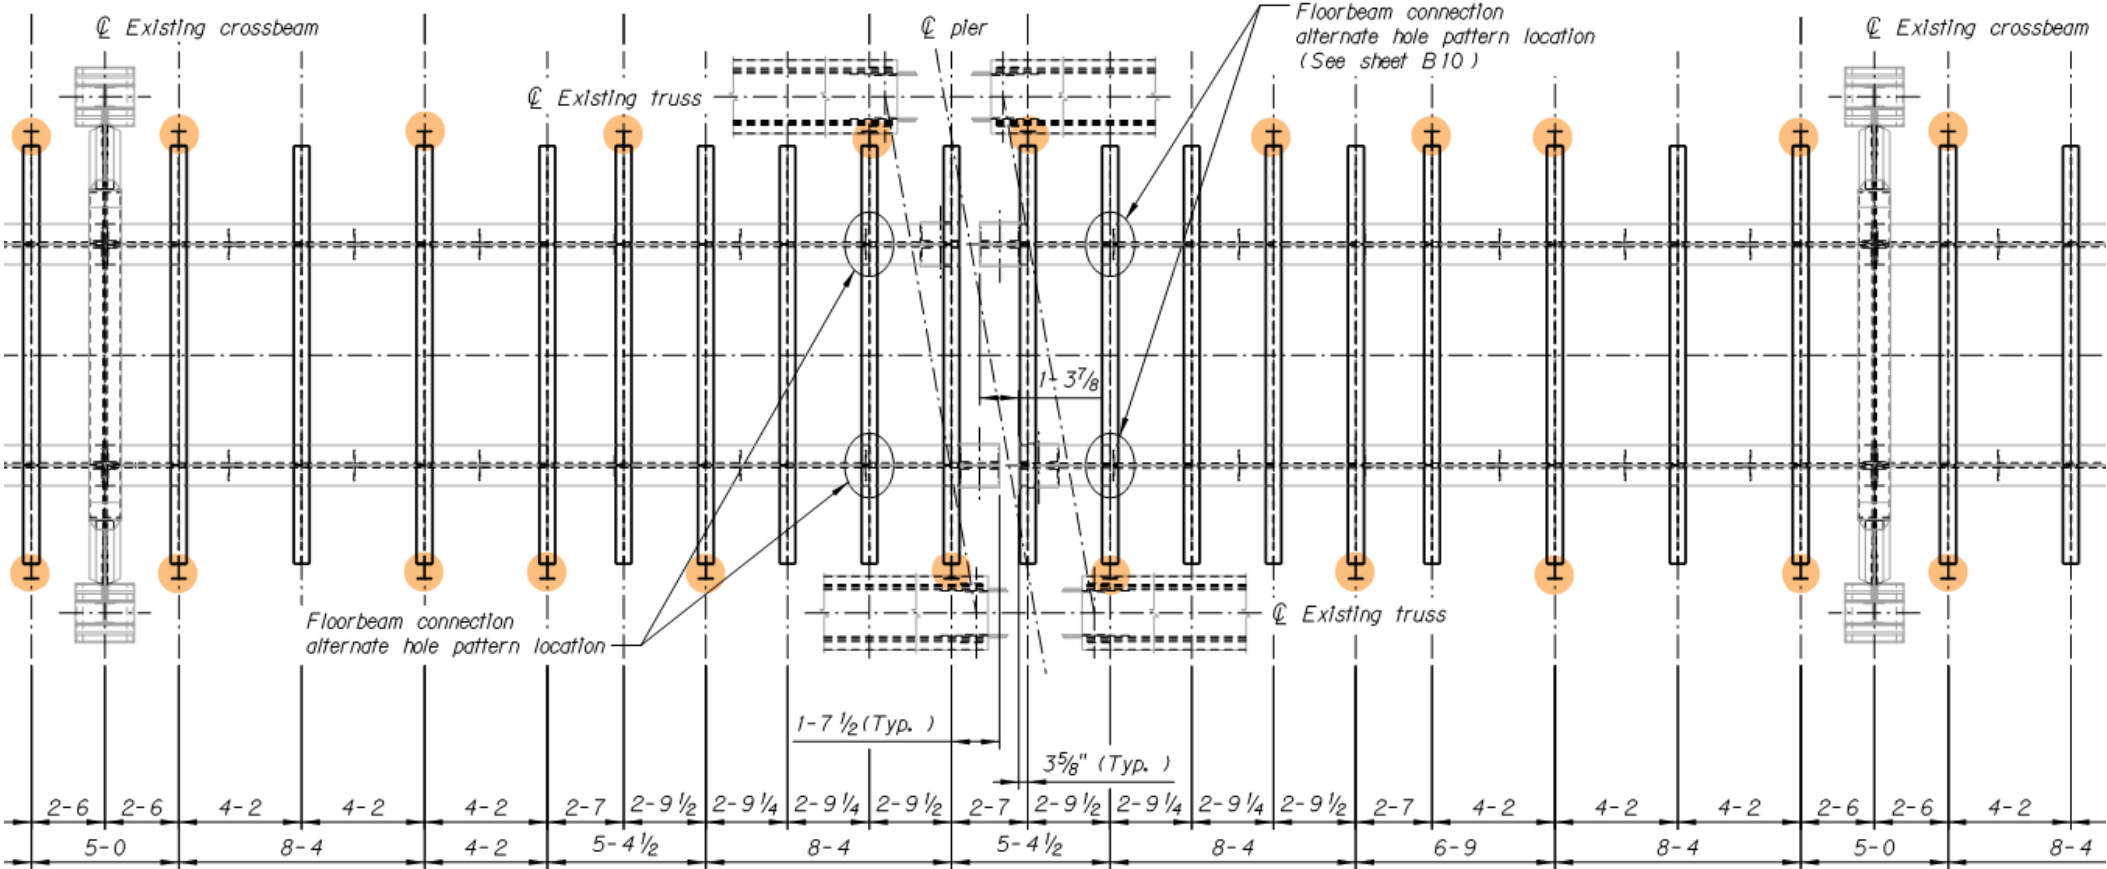
DECK FRAMING PLAN AT PIER

Floorbeam Spacing

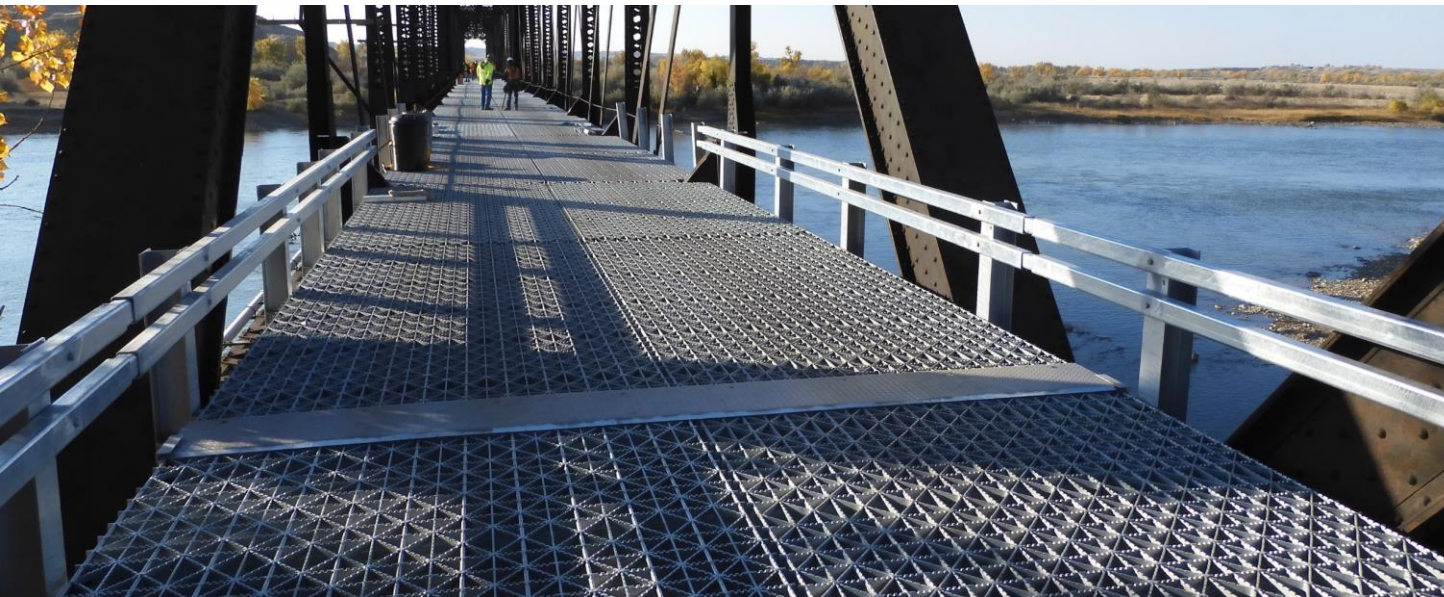
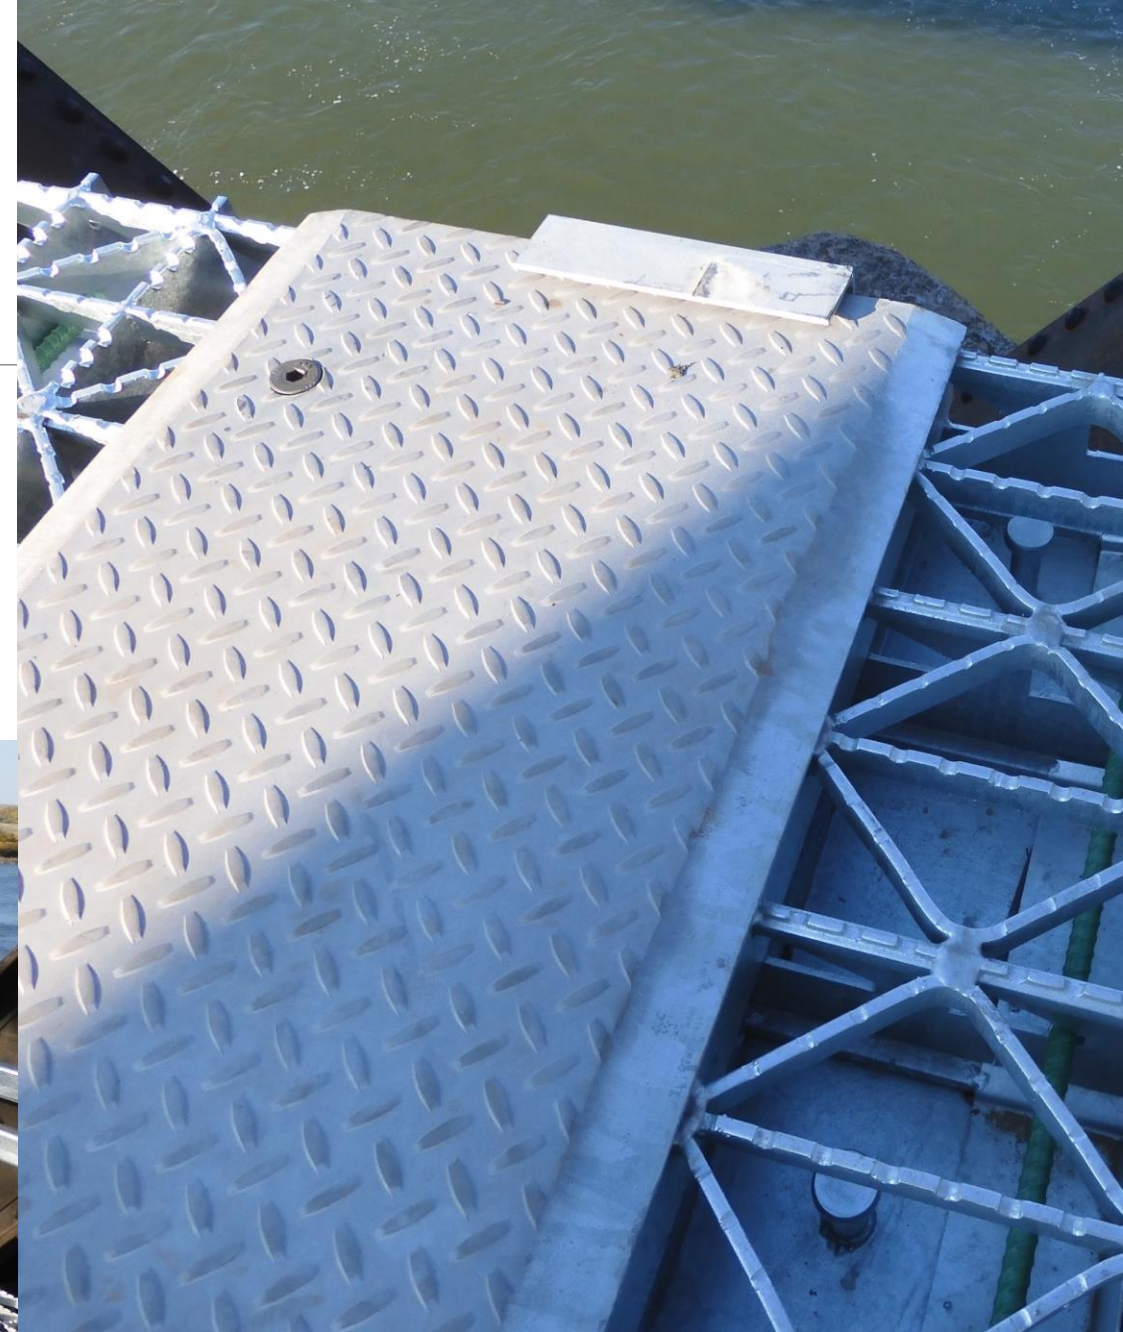
Expansion Joint

- ❖ Low Road Speeds (15-20 mph).
- ❖ Tapered plates were selected as a simple and economical choice.
- ❖ Plates textured to provide traction.

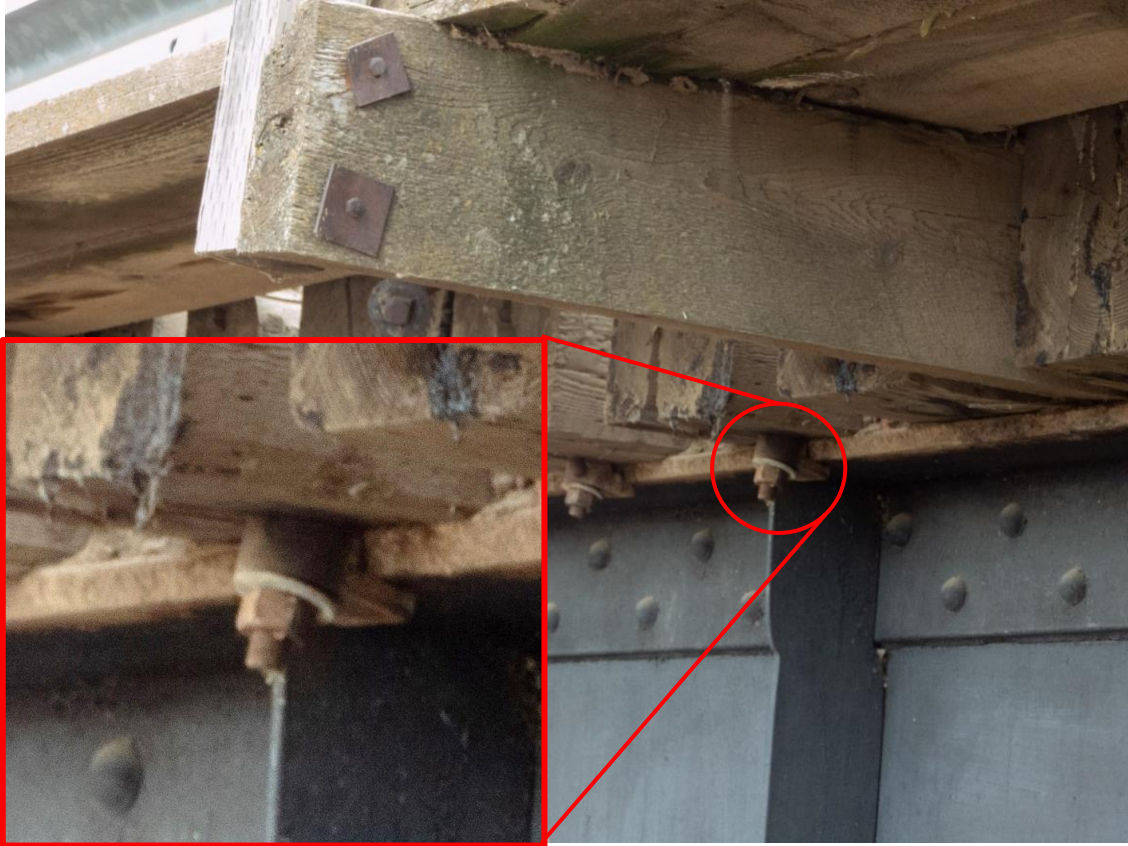
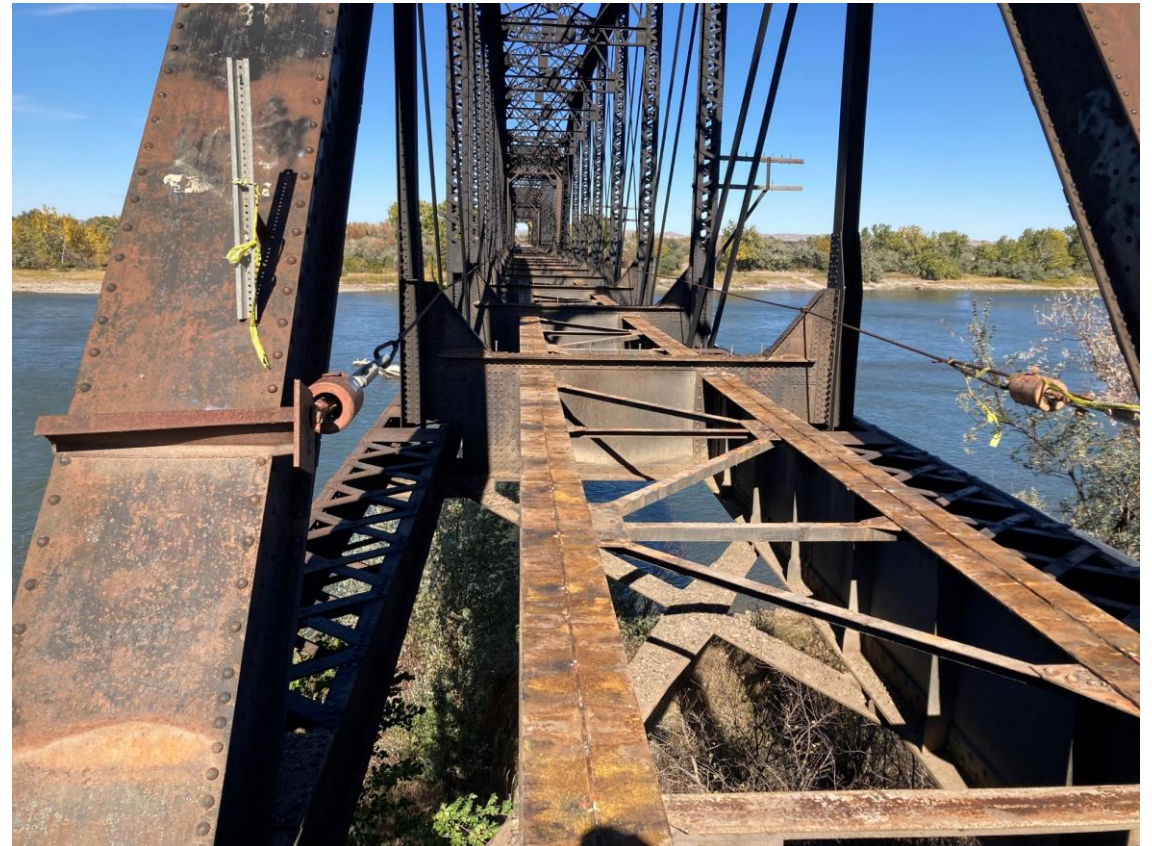
Remove Old Timber Deck

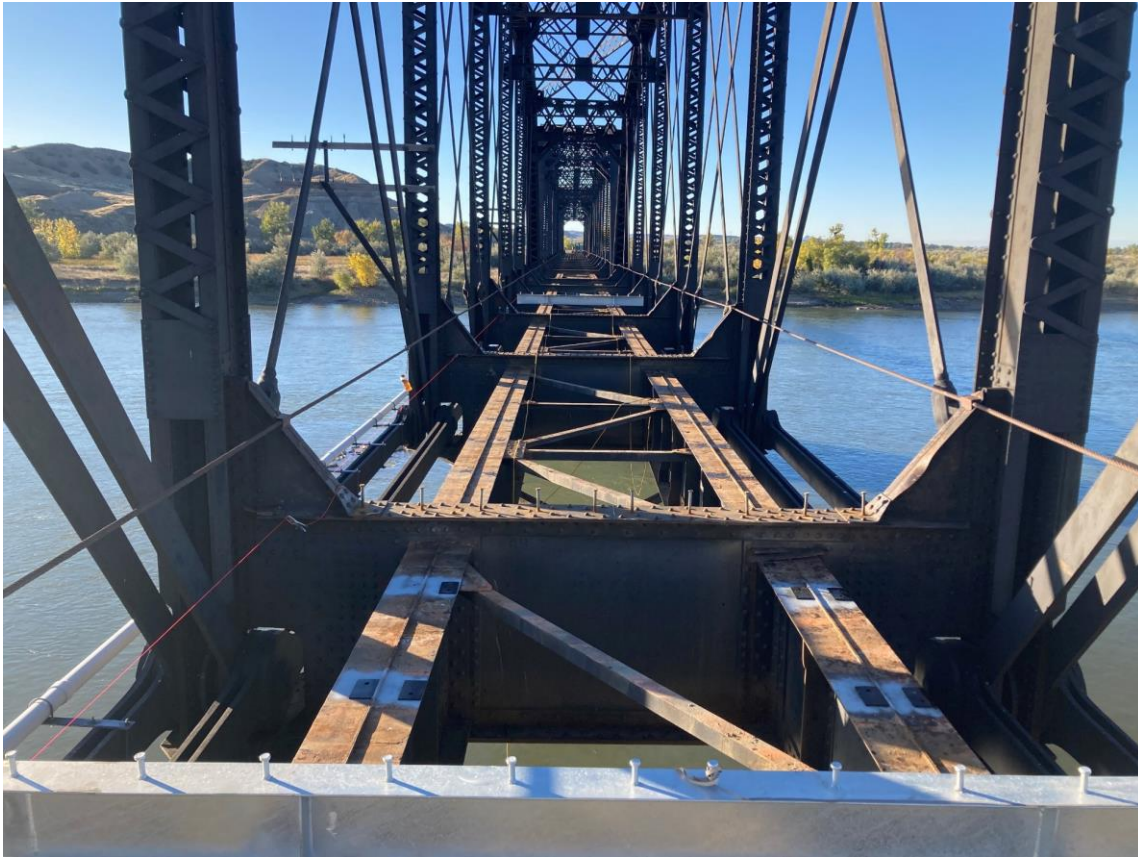
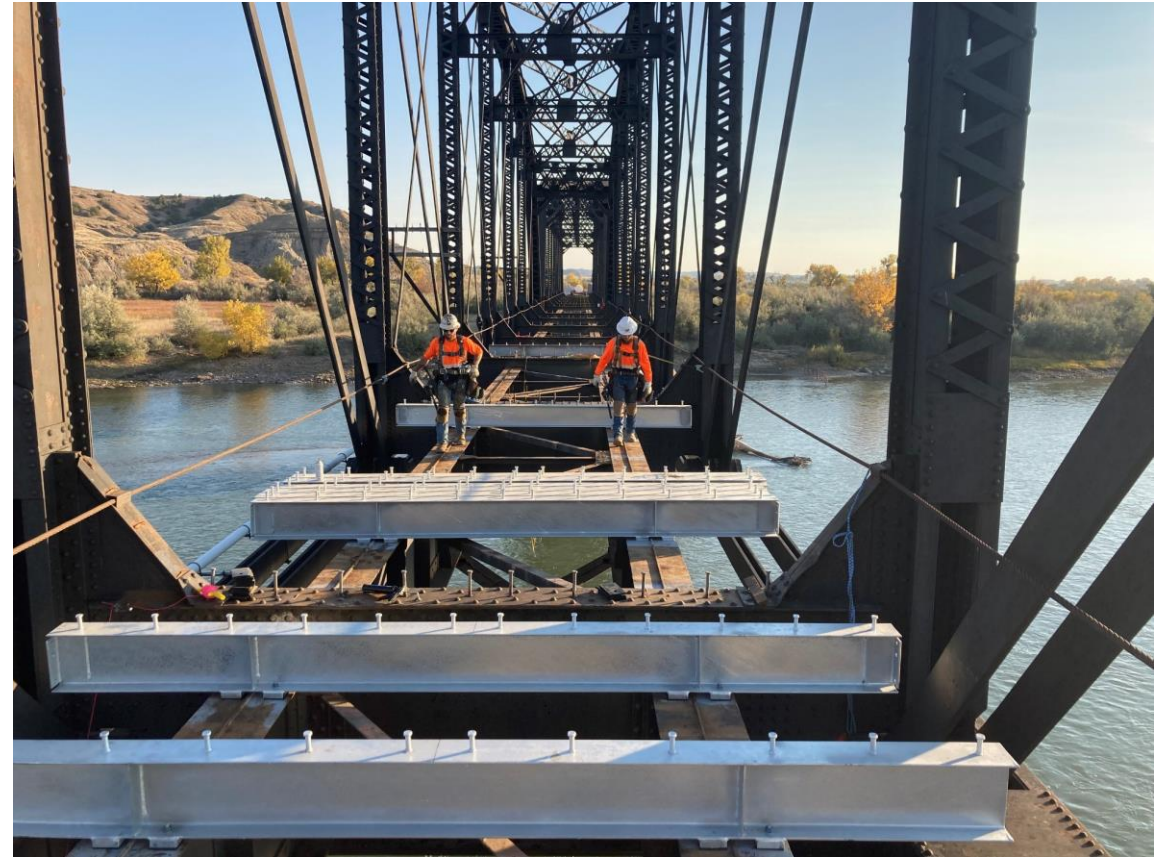
Drill Holes & Place Floorbeams

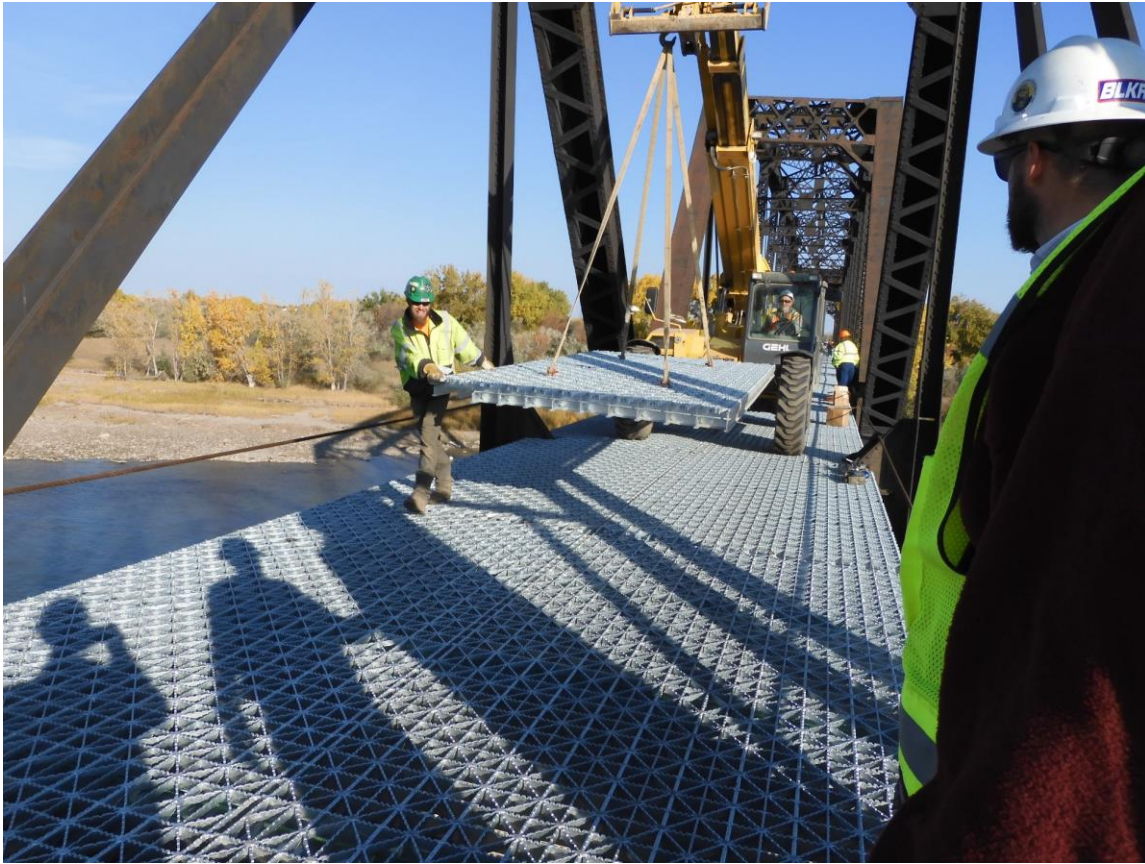
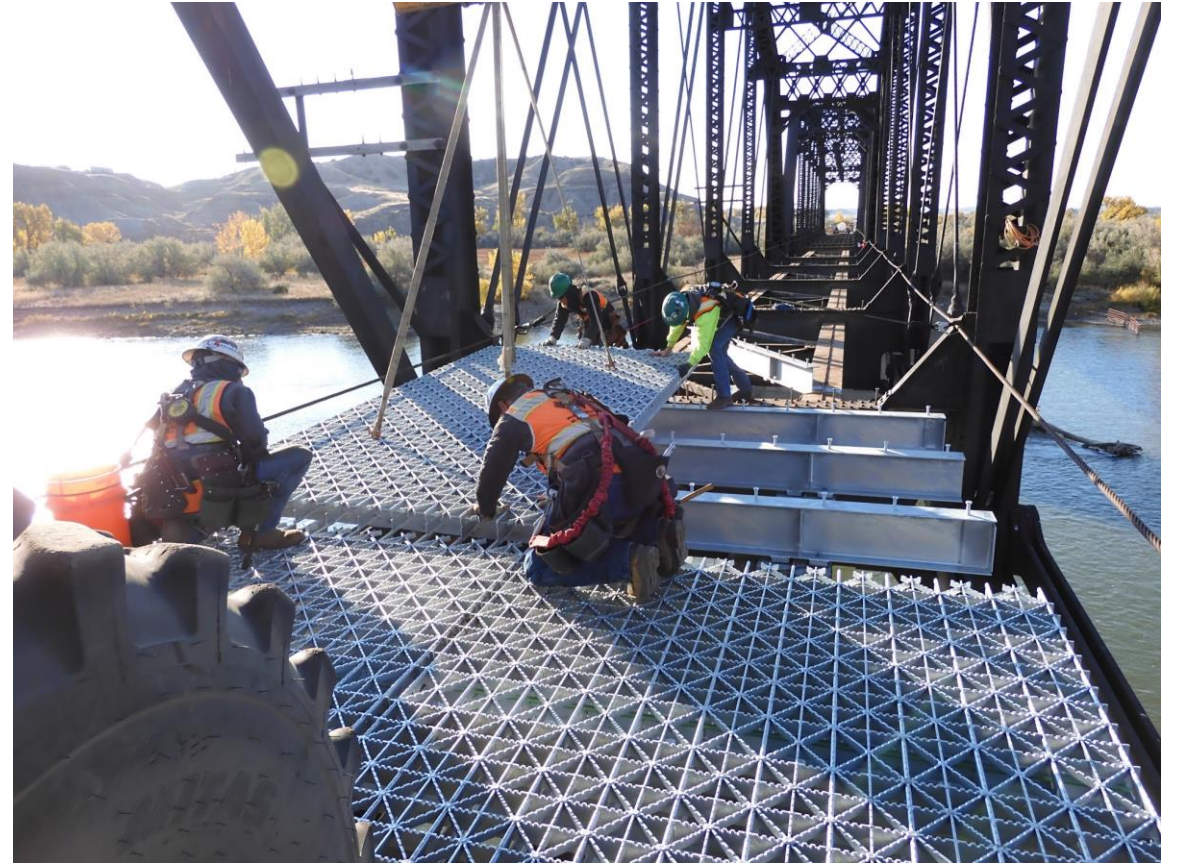
Deck Panel Installation

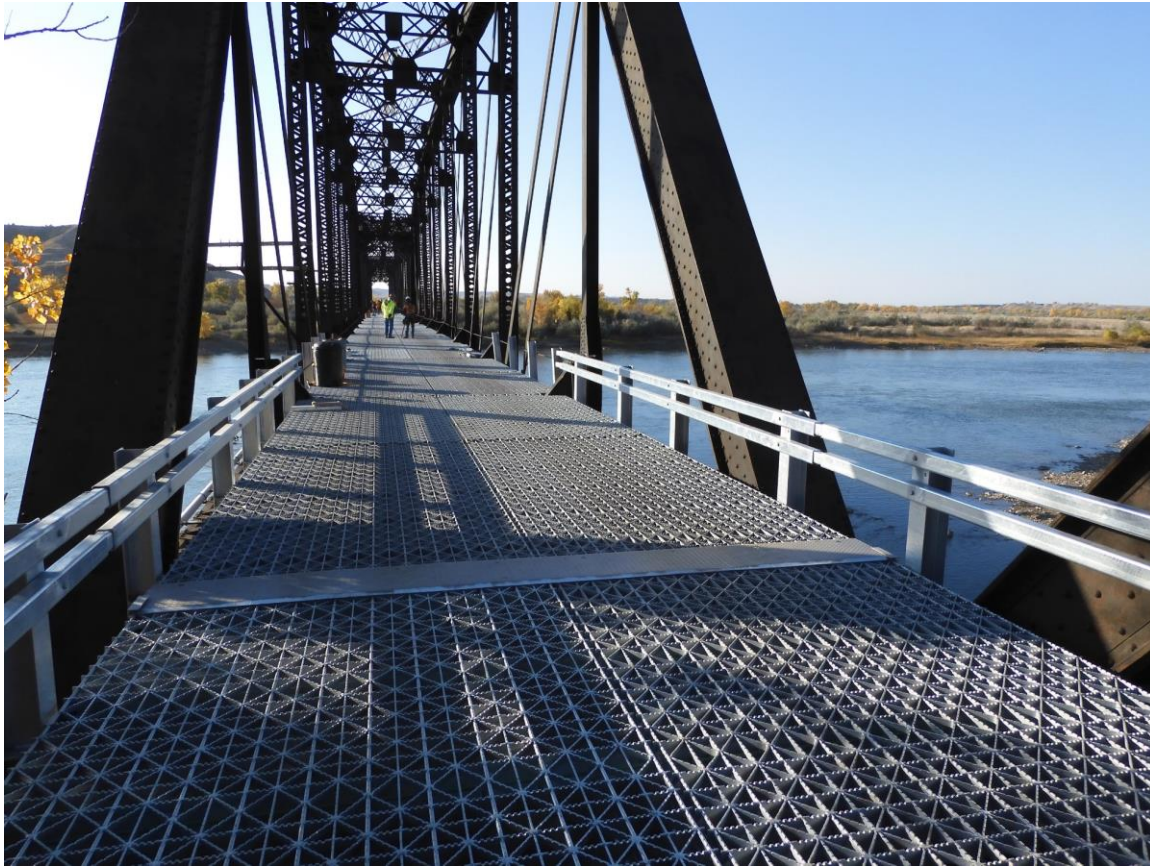
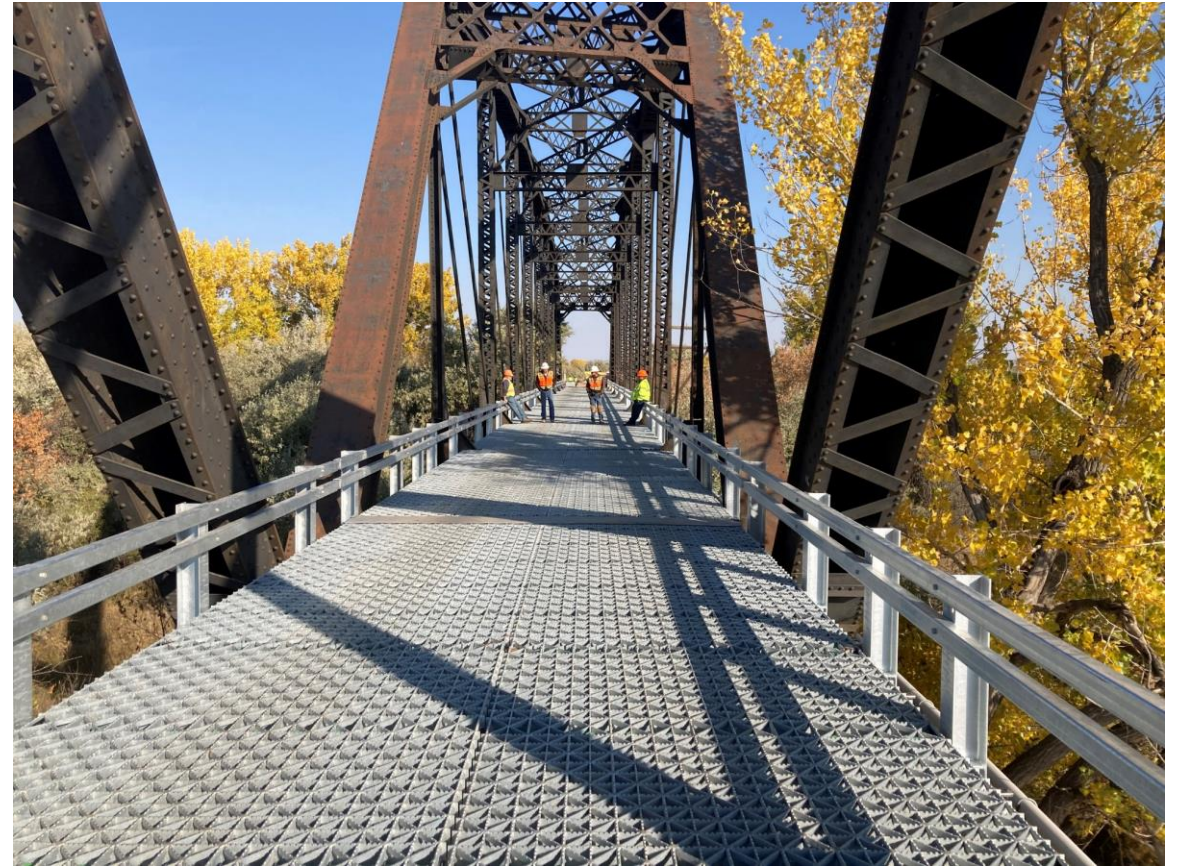
Expansion Joint Plate & Railing

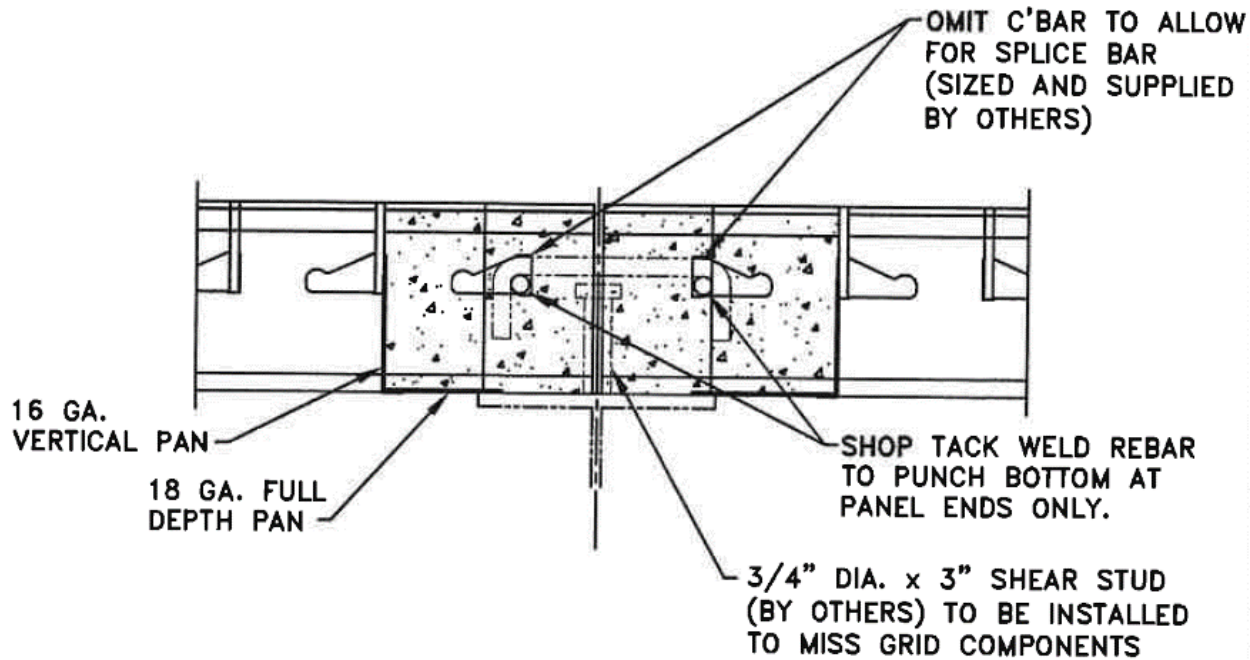
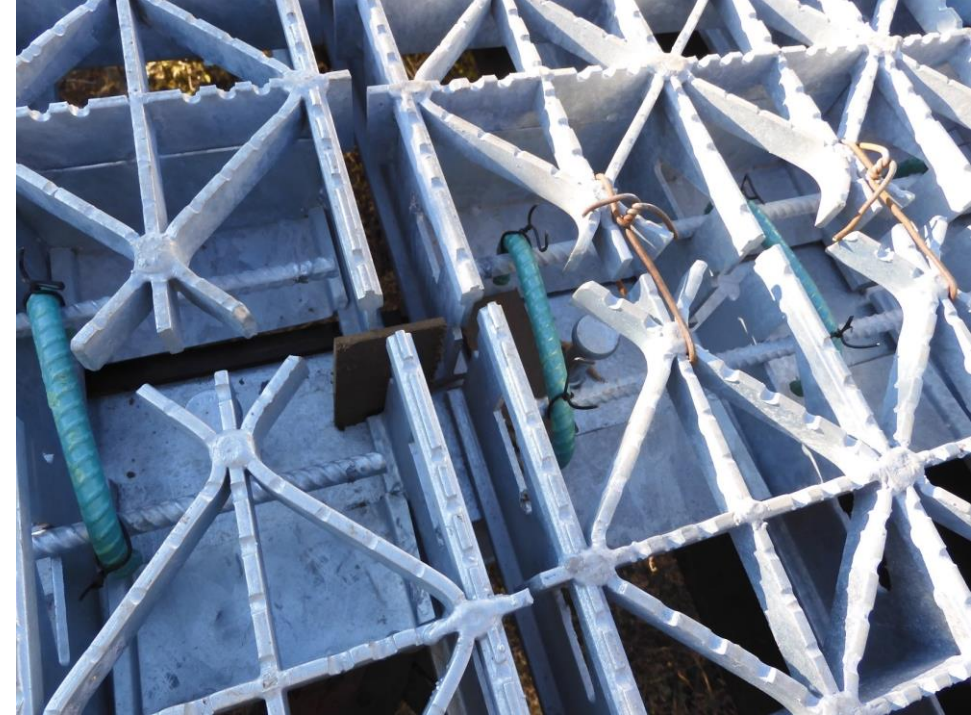
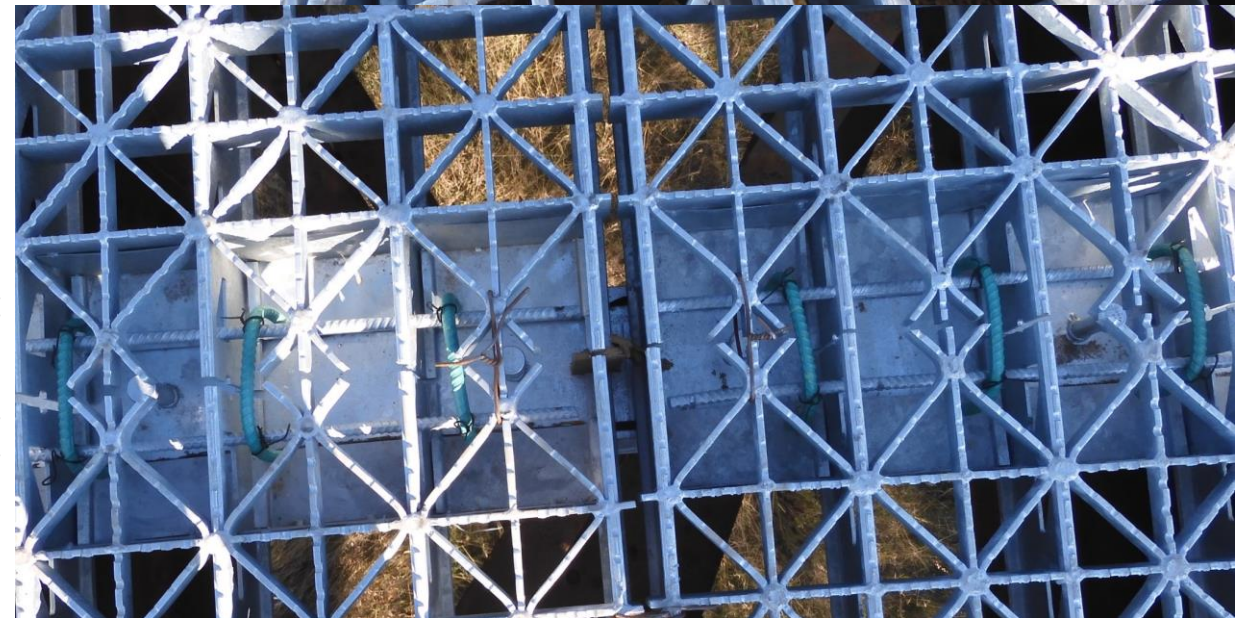
Deck to Floorbeam Connection

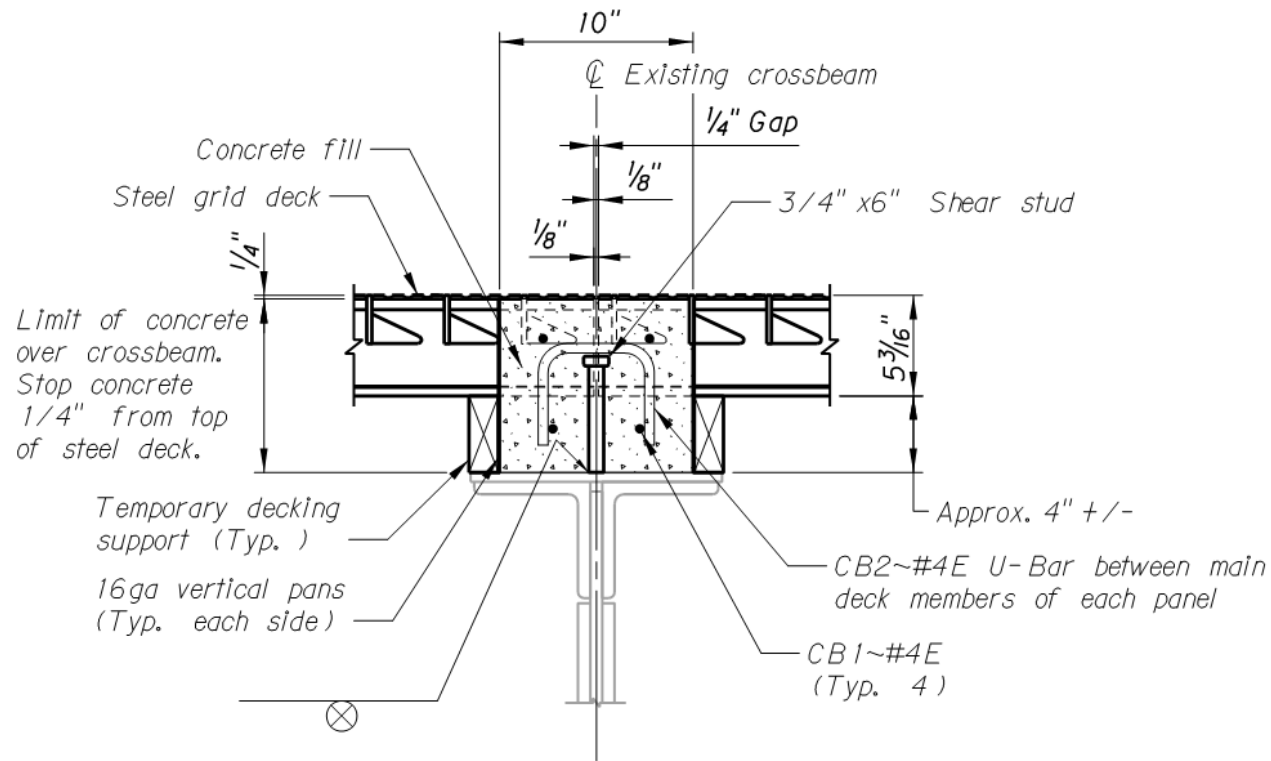
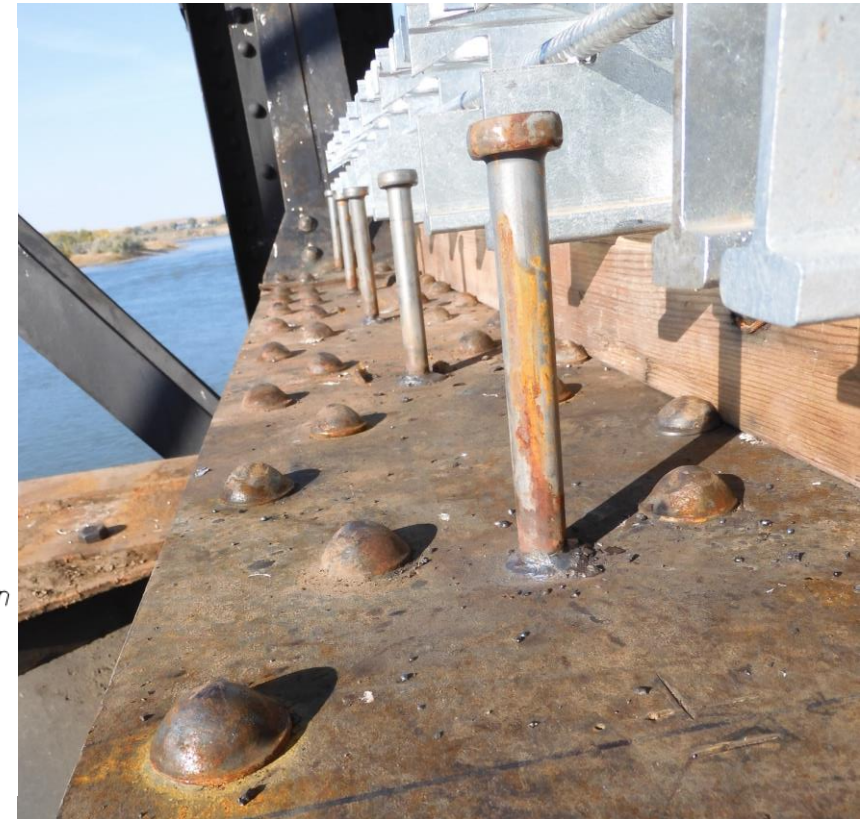
Deck to Crossbeam Connection
