Kinsey Bridge Metal Grid Deck Replacement

PRESENTERS:

BRENT SCHILLER, P.E., S.E.

JARED LARKIN, E.I.T.

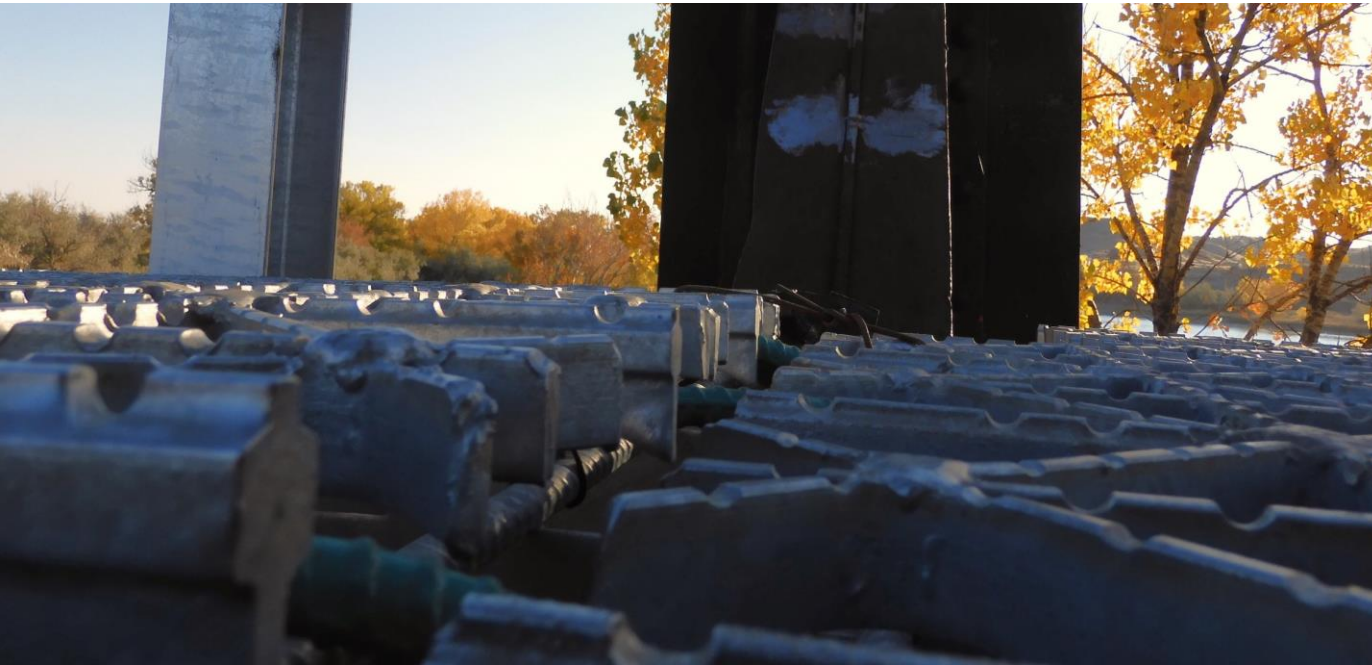
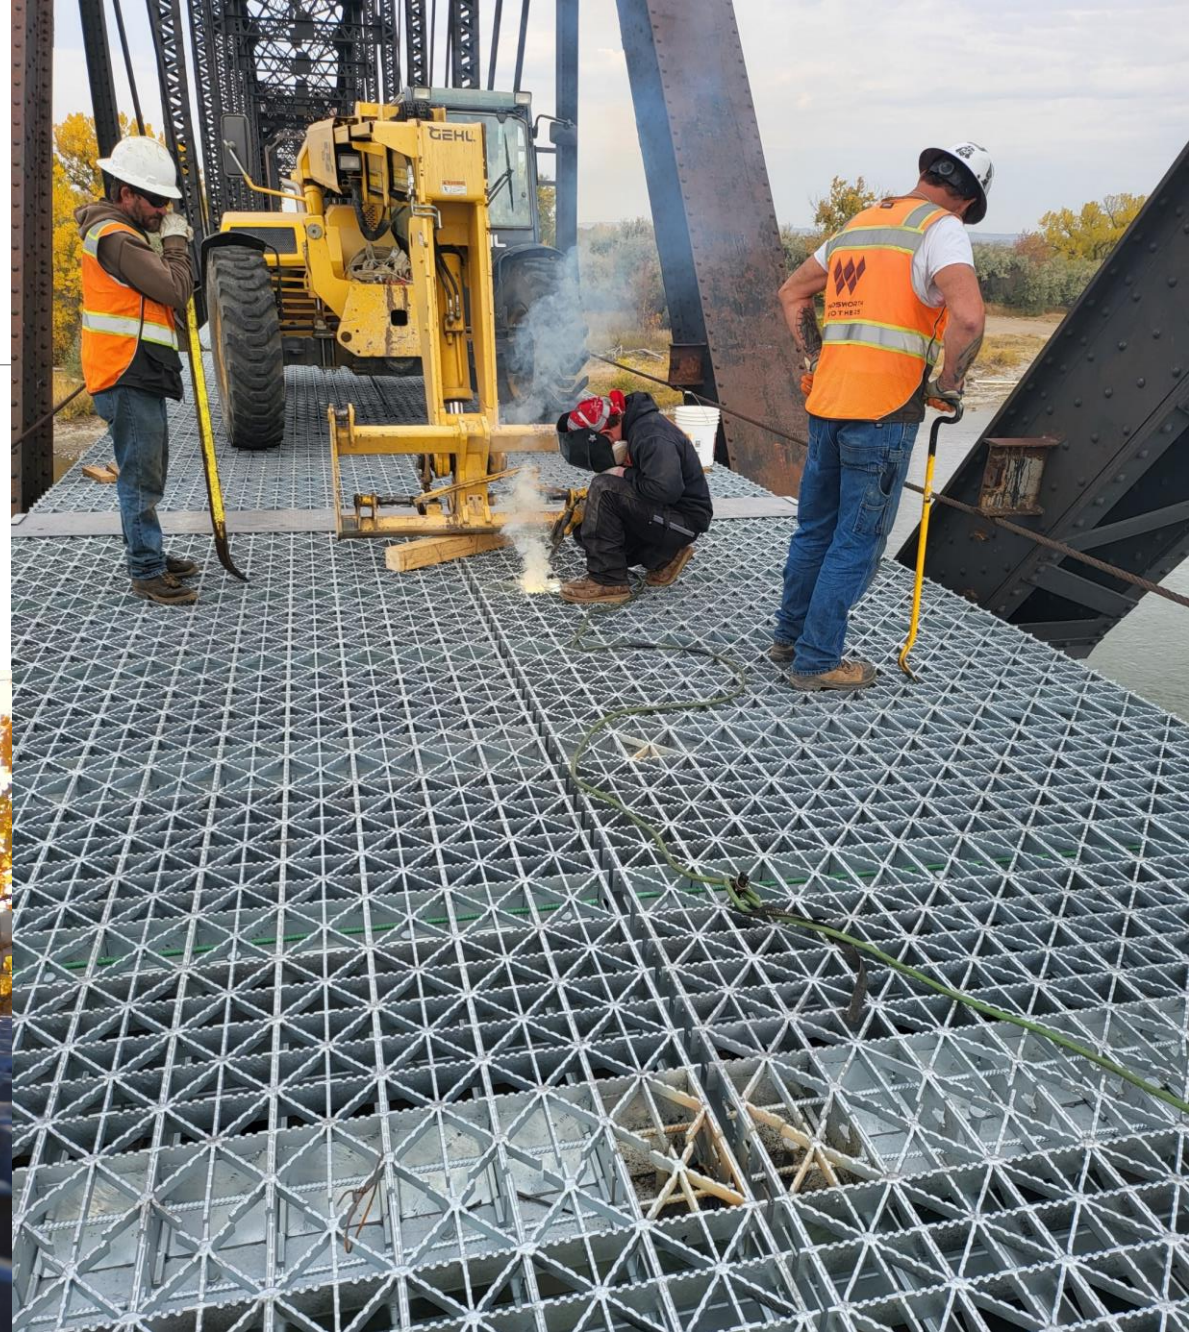
- ❖ Some Deck Panels were not resting flat.
 - Tack welded in non-tension zones

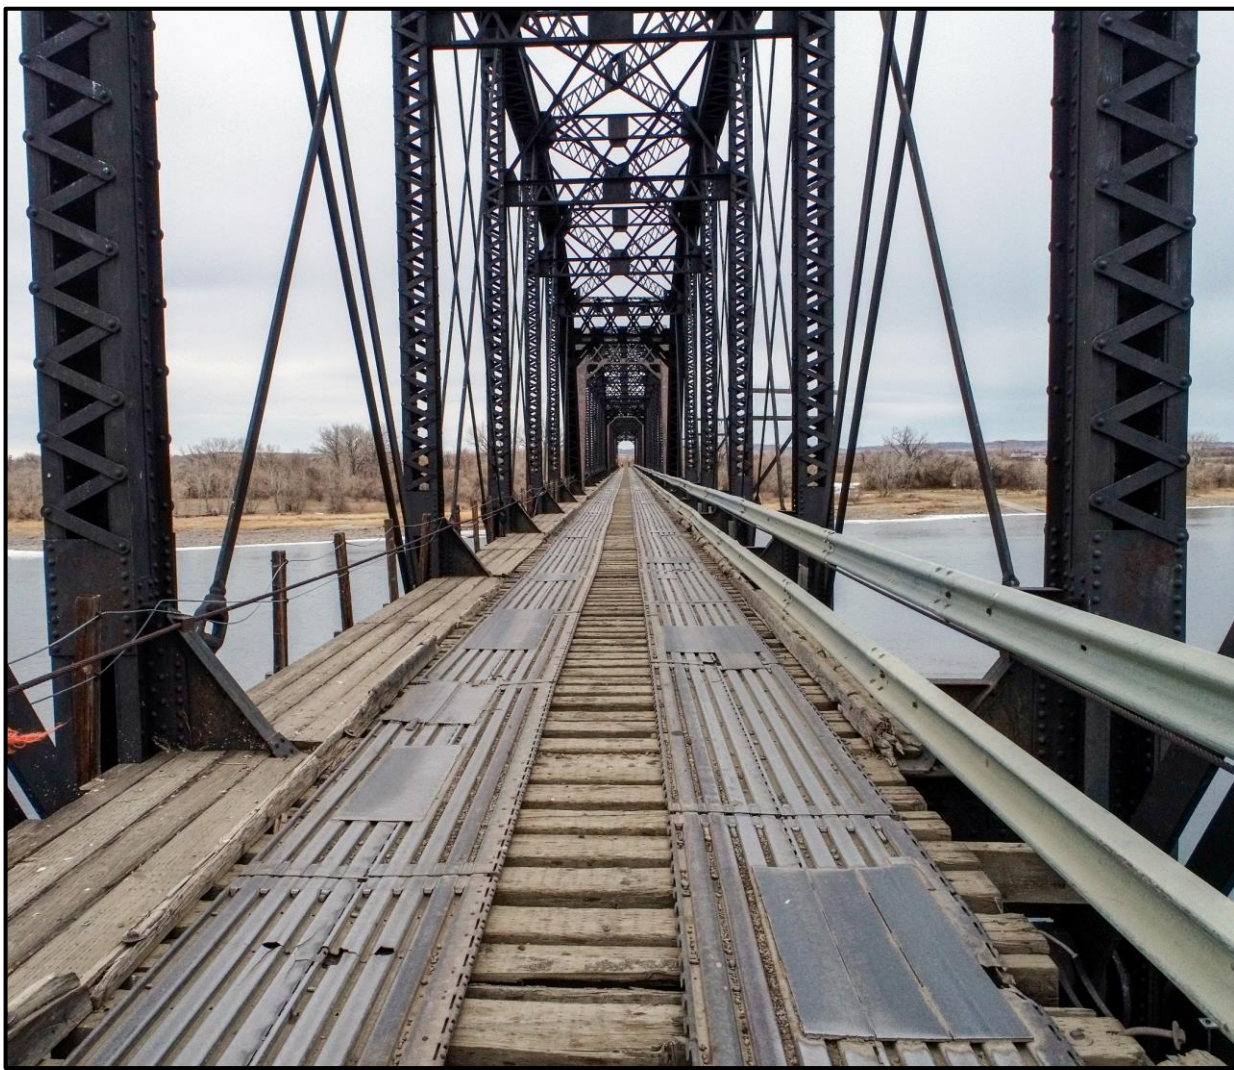
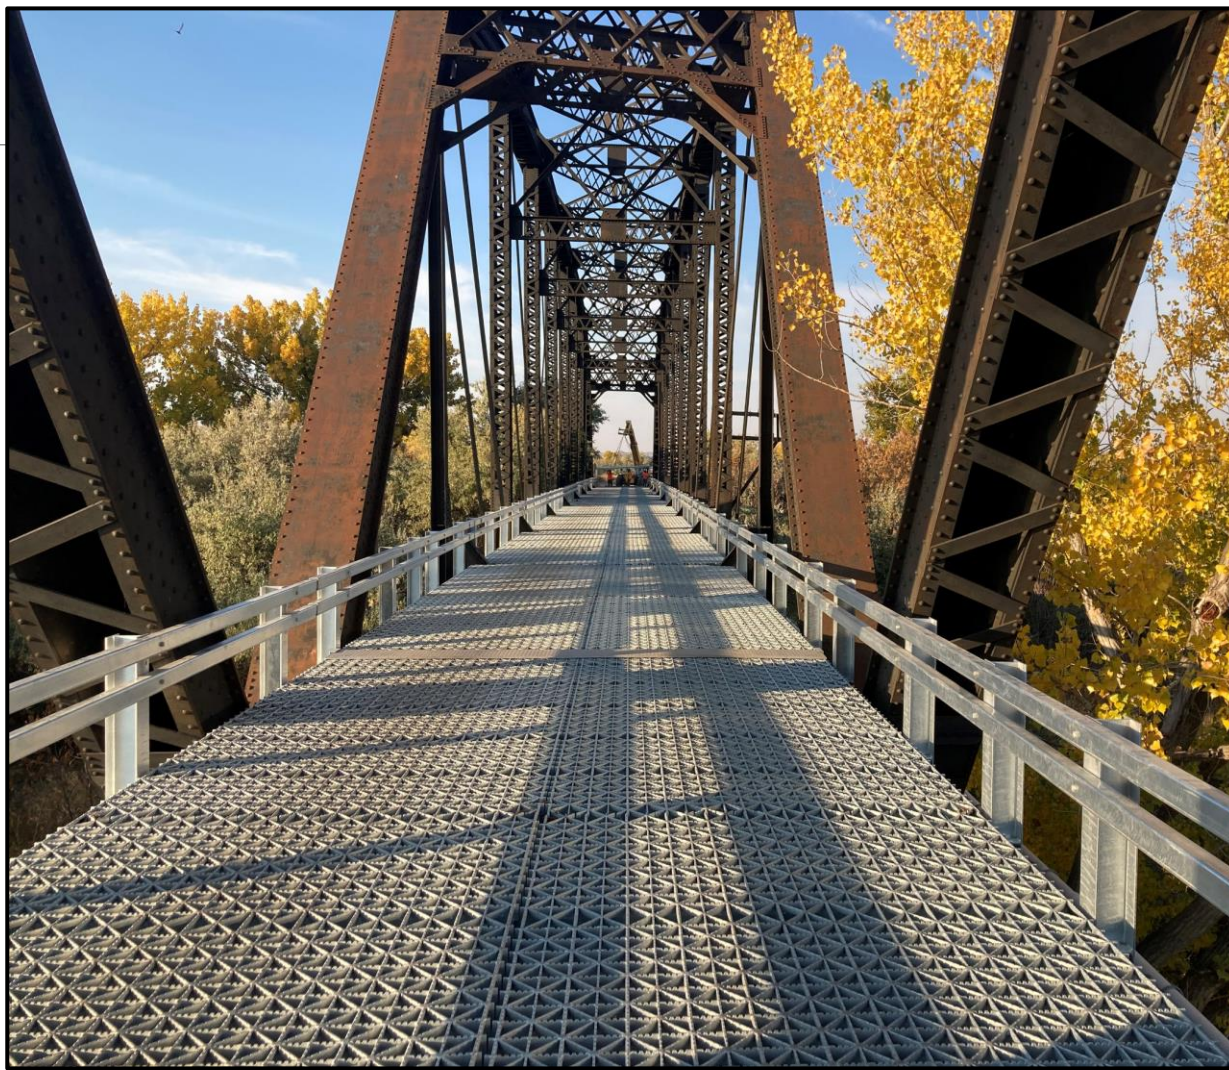
Before and After
